CONNECTING BROADWAY-FILLMORE

ARC607/URP581-582 - FALL 2021

PUBLIC SPACE

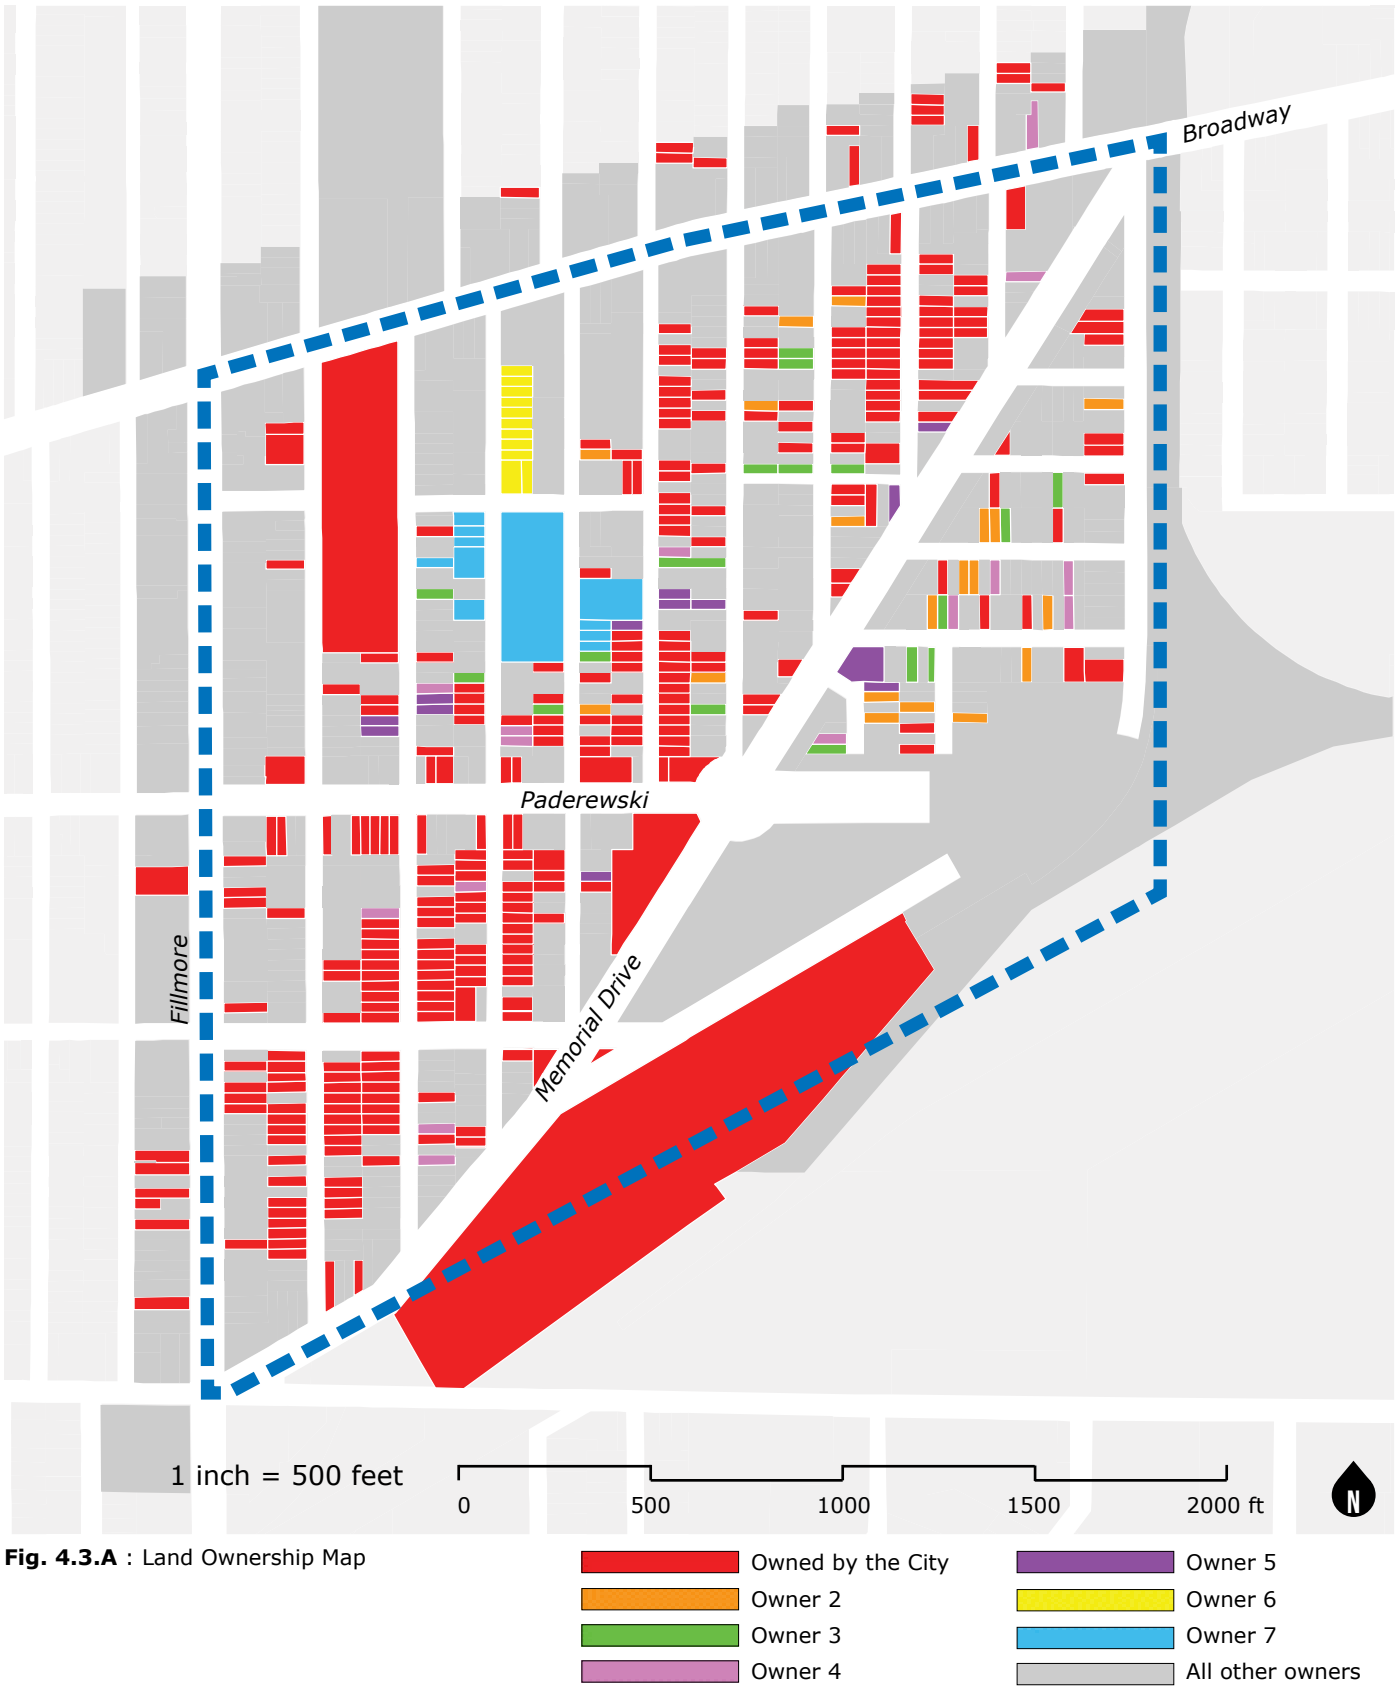
Fig. 4.3.A : Land Ownership Map

Figure 4.3.A is a map that shows all land ownership within the Broadway-Fillmore Triangle. All the red parcels are owned by the City of Buffalo and all other colored parcels of orange, green, pink, purple, yellow, and blue are owned by six other property owners who own ten or more properties within this area. All other property owners who own less than 10 properties are shown in gray. Figure 4.3.B also shows the City of Buffalo's ownership when compared to all other land owners. Out of the 1,058 properties in this triangle, the City of Buffalo owns 308, accounting for 29.11% of the total land in the area. Other land owners who own more than 10 properties only account for 8.13% of the total land in this area.

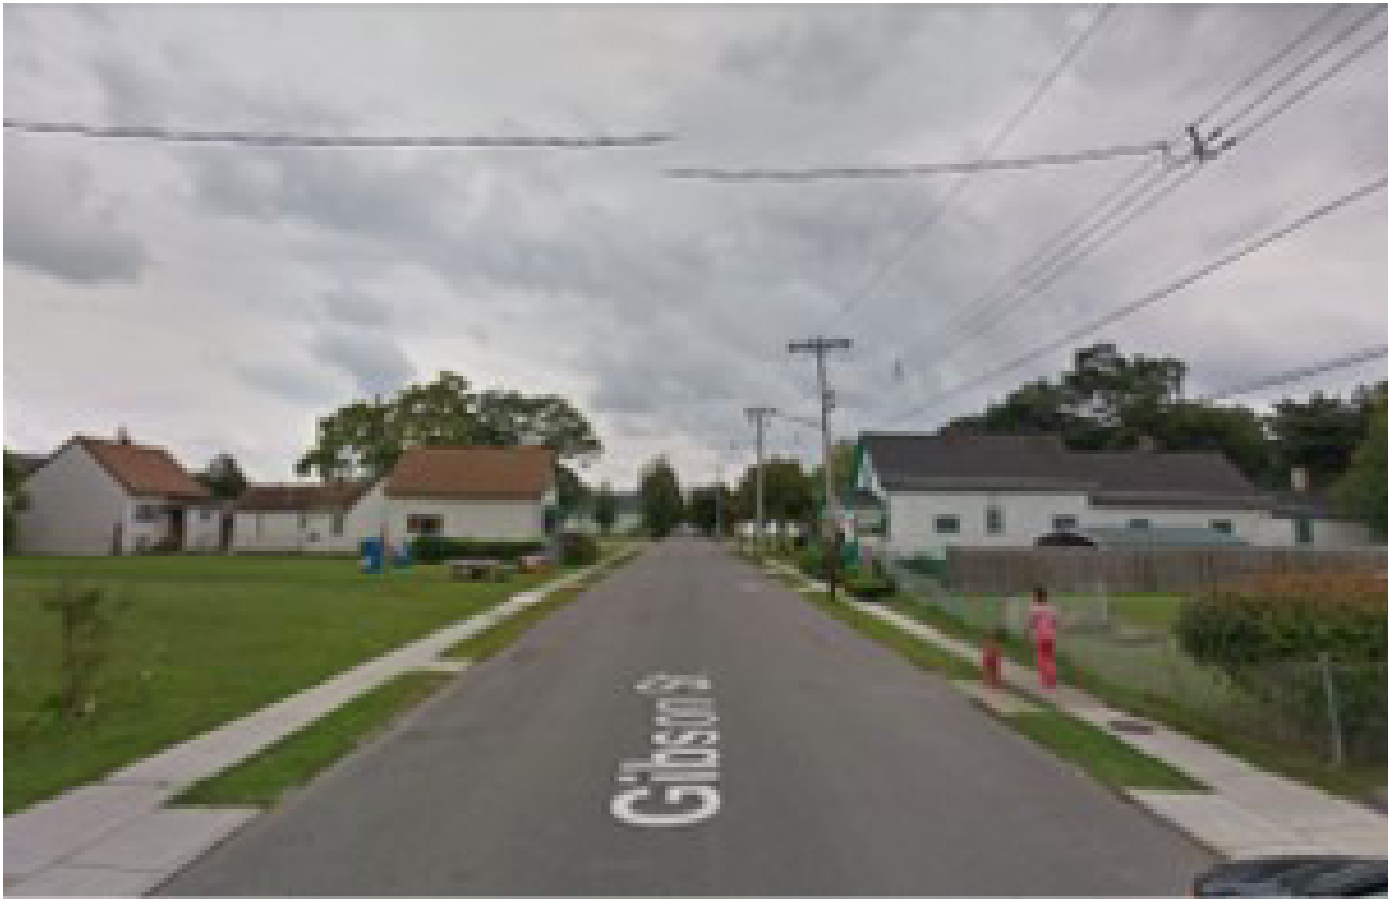
Fig. 4.5.A : Good Condition sidewalk (photo source- Google Streetview)

In the Broadway Fillmore Triangle, five typologies of sidewalk were defined in order to study their condition. Research was done using Google Earth Street View and findings can be seen in the map in Figure 4.5.F. The first typology is sidewalks that are in “good condition,” which includes ones without cracks or tripping hazards, with a trimmed landscape along its edges and enough space for two pedestrians to cross paths comfortably. The chart in Figure 4.5.F shows that 50% of the sidewalks surveyed are currently in good condition. The second category is sidewalks that are in “medium condition,” which have few cracks and no tripping hazards, partially trimmed landscape, and enough space for two pedestrians to pass each other comfortably. Thirty-seven percent of surveyed sidewalks fall into the medium condition category.

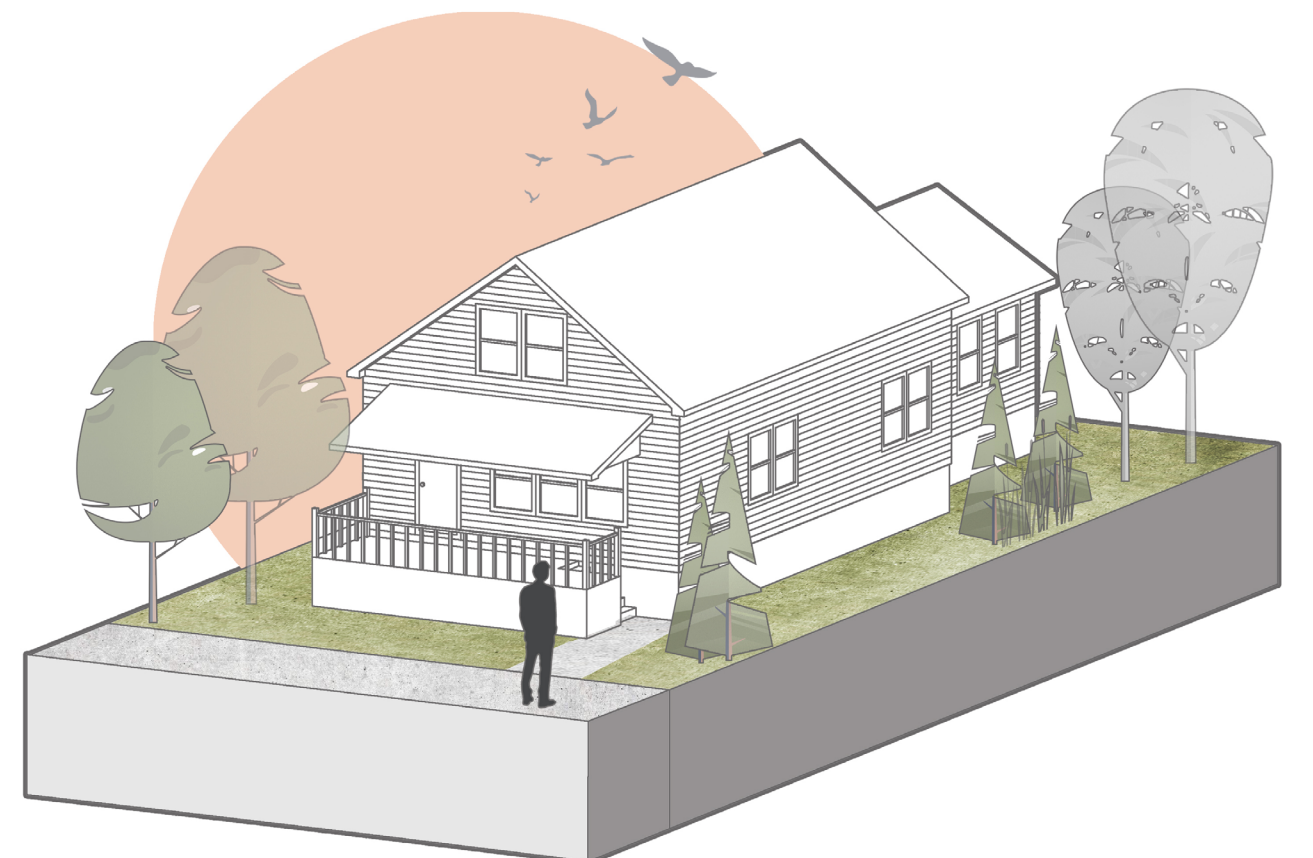
Fig. 4.6.D : Illustration of no trust in residential area (source- author)

This category includes undefined vacant land parcels or occupied land parcels with built structures and no signs of habitation. Unkempt front yards and lack of personal belongings, furniture, lighting or streetscape features indicate poor and decaying neighborhoods that need attention from authorities and planners. These characteristics are often observed in areas that also have poor sidewalk conditions and infrequent pedestrian traffic. In the Broadway Fillmore Triangle, land parcels under this category make up the majority, or 58%, of the area. Signs of no trust and no personalization are typically found close to abandoned buildings, including the Central Terminal and surrounding area, indicating a possible correlation between trust and frequent regular use of spaces.

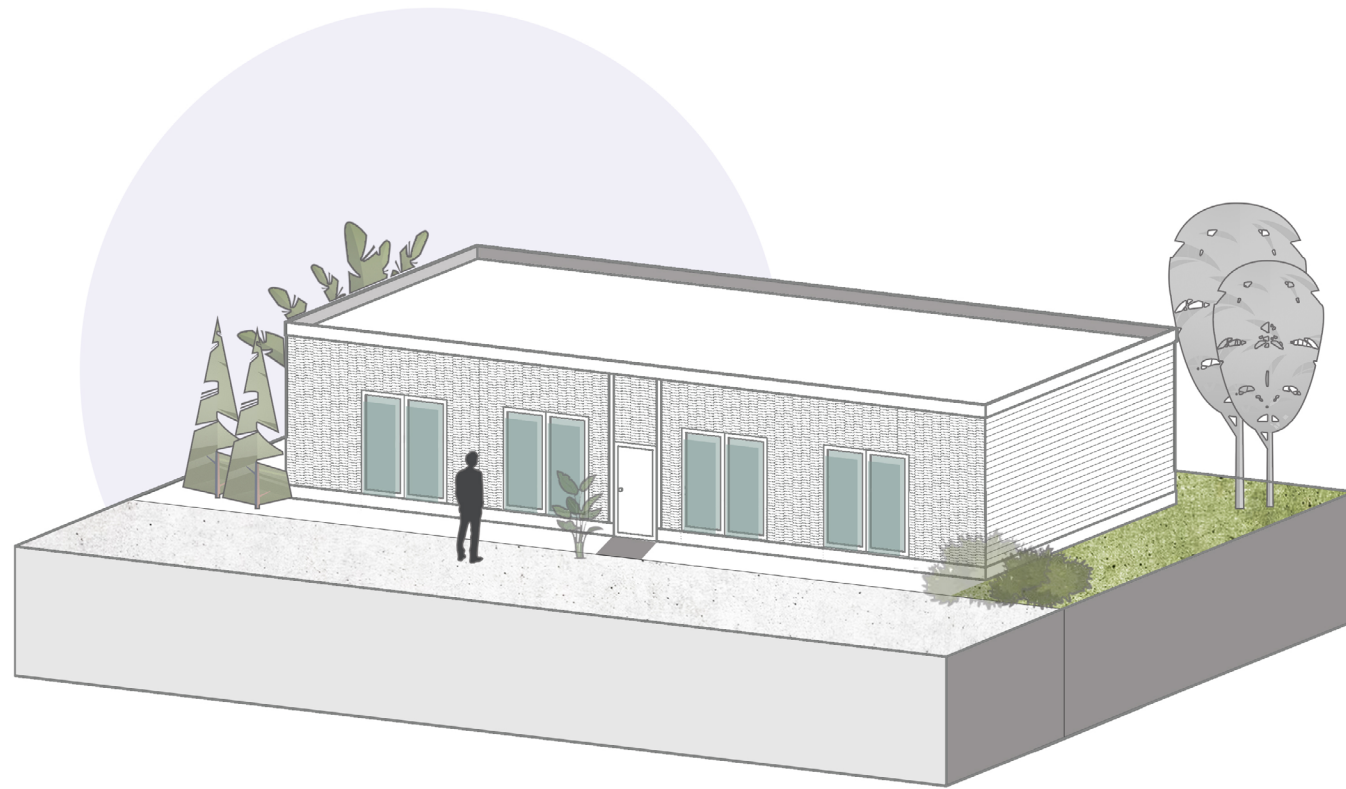
Fig. 4.6.E : Illustration of medium trust in commercial area (source- author)

Commercial/ mixed use land parcels in this area mostly fall under this category. They show moderate levels of trust with minor signs of personalization. Visual and physical access to such buildings/ lots are not rare. Signs of personalization include temporary or permanent awnings, outdoor furniture, full length windows/ openings, porous facades, welcome boards and markers. Street connectivity and allowances for interaction are key factors of this category. Similar to the residential area, trust here is also contagious. It is a general pattern on Broadway street to find rows of commercial units adjacent to each other with medium levels of trust. Parks can also amplify this behavior by acting as a catalyst to developing trust in the neighborhood.

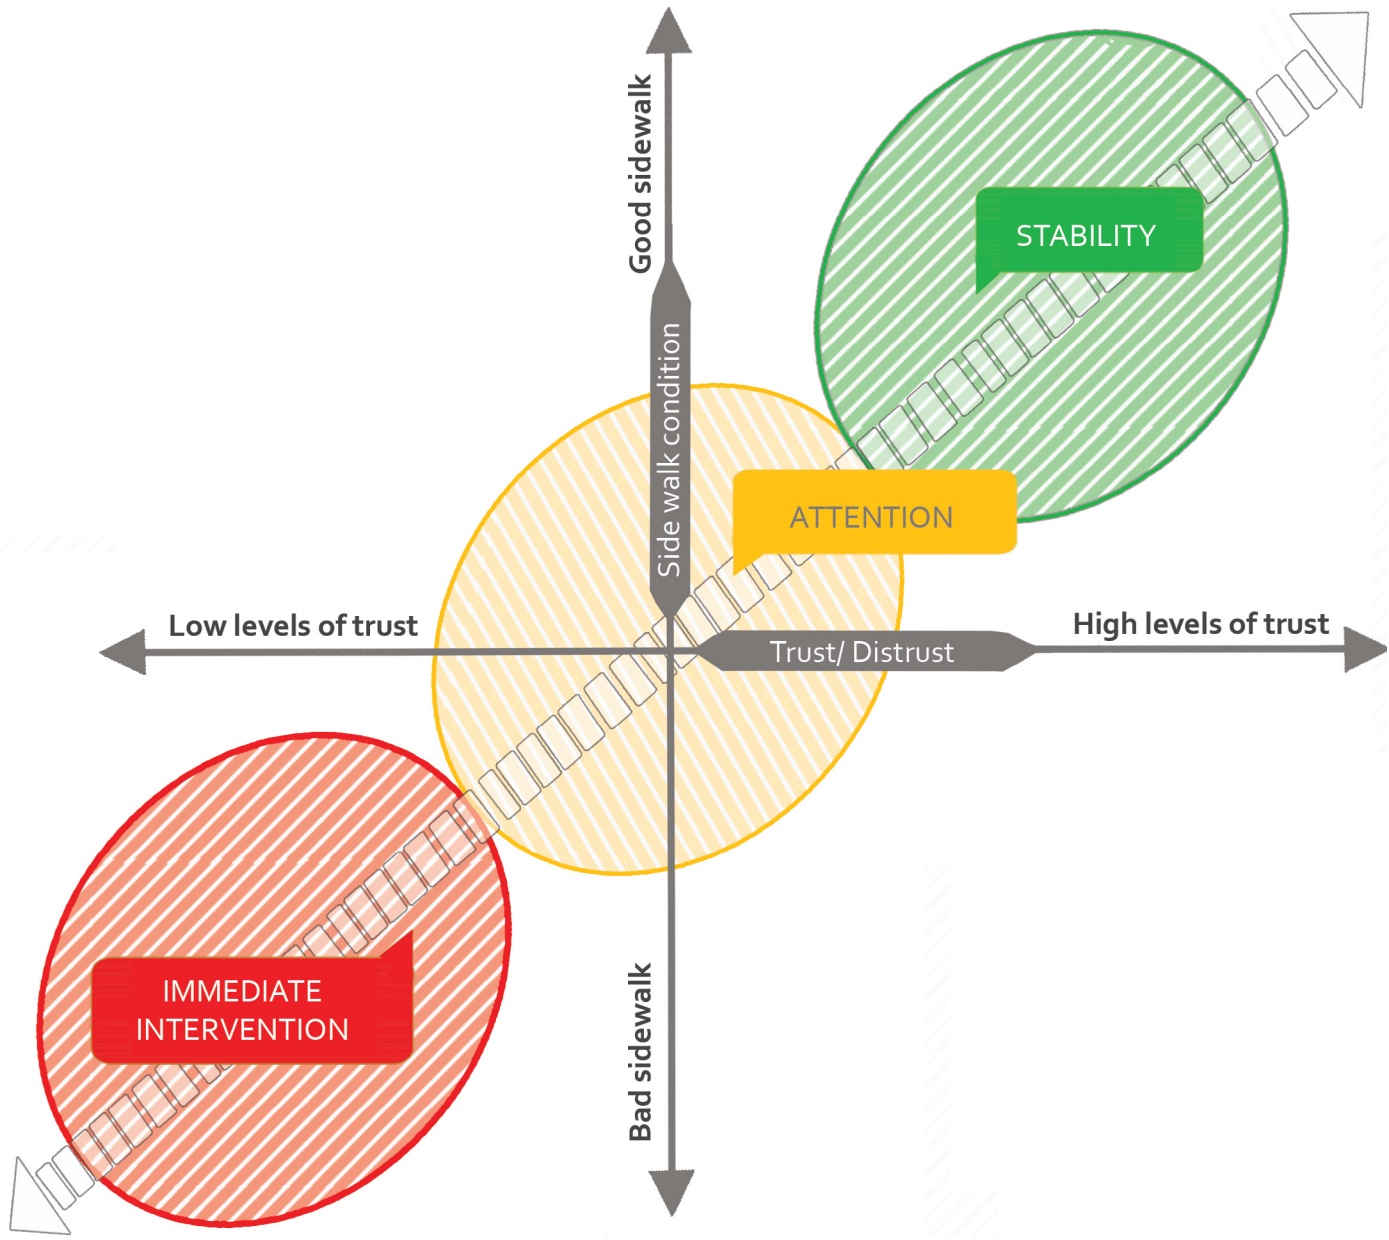
Fig. 4.7.A : Graph representing understanding of different categories based on sidewalk condition and levels of trust and distrust

The eye level structure aims to capture the overall human experience of the Broadway Fillmore Triangle based on sidewalk condition and levels of trust and distrust as they are distributed throughout the neighborhood. Three categories, or zones, are used to understand conditions found at eye level (Figure 4.7.A). Areas that have high levels of trust and good sidewalks fall into the “Stability” category. “Attention” describes zones with medium levels of trust and medium sidewalk conditions. “Intervention” includes zones with low levels of trust and poor sidewalks. Looking at where these categories fall spatially and in relation to the neighborhood’s major nodes and corridors, reveals overarching patterns as seen in the conceptual diagram in Figure 4.7.B.

Stability is concentrated in the small triangle of short, residential blocks east of Memorial Drive, just north of the Central Terminal. Attention is needed in the largely residential areas located centrally in this neighborhood. The area south of Paderewski Drive exhibits characteristics that need the most immediate intervention. Nodes are distributed mainly throughout the northwest and southeast corners of the Triangle, but there is not a major corridor running in this direction. A northwest-southeast corridor would run through the large “Attention” zone and therefore would require improvements. A closer look at sidewalk connectivity and vacant land could provide inspiration for targeted infrastructure improvements and reimagined streetscapes or establishment of green corridors with multi-use paths connecting the Broadway Market in the northwest with the Central Terminal in the southeast.
